**FREMANTLE PORTS NOTICE TO MARINERS
2(T)/2020**

**FREMANTLE PORT
Hall Bank Beacon**

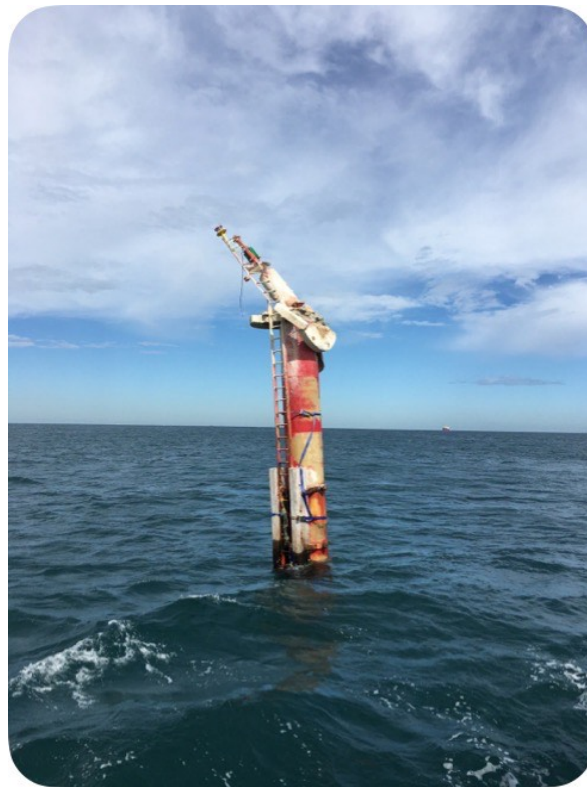
Hall Bank Beacon - *damaged.*

Mariners are advised that the Hall Bank Beacon has had the loose concrete removed and a temporary light fitted.

Mariners are advised to navigate with caution.
